**Flood Control Project Maintenance
Levee Inspections**

Fall 2018 Levee Maintenance Deficiency Summary Report

Reclamation District No. 2092 Dos Rios

Waterway			Bank	Unit Miles
Unit No. 01 San Joaquin River			Right	3.71
	Spring (March - May)	Summer (June - August)	(September - November) Fall	Winter (December - February)
Unit Maintenance Rating (Fall Only)			U	
Date of Inspection	3/29/2018 - 3/29/2018		10/4/2018 - 10/4/2018	
DWR Inspector	Richard Willoughby		Corey Fujitani	
Accompanied By

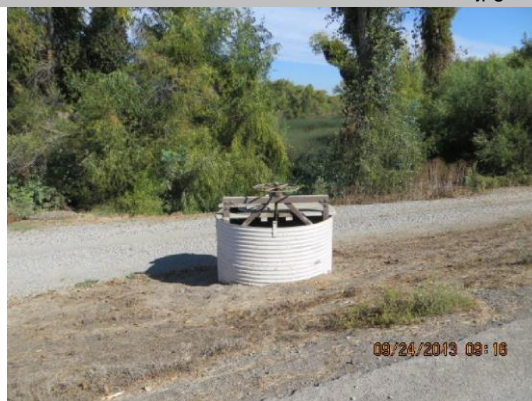
Photo 1 of 3 : UCIP_FA_2018_27123_50242.jpg

LM Start	0.18	Rating **	M	Issue No.	973
LM End	0.18	Issue Type +	Ma	Location *	
Category	Supplemental			GPS Latitude/Longitude	
				Start	End
Item	DWR UCIP LMA Responsibility			37.602031°	37.602031°
				-121.161249°	-121.161249°
DWR ID	20561				
Comment Code					
Inspector Comment					
FS_ID:27123 DS_ID:20561 EP_NO: N/A Repair Type: Non-Urgent Crossing Status: Found UCIP Comments: 09/24/2013 Pipe rusted through at headwall on LS toe. Good candidate for video inspection. (W. Wylie - DWR UCIP) FIELD_STRUCT_DESC: 60-inch corrugated metal drainage pipe through the levee, 19 feet below the crown. Flap gate on the waterside (WS) end. Slide gate in an 80-inch corrugated metal pipe (CMP) riser on the WS slope. Concrete U-shaped headwalls on both ends. [Additional Reference(s): DWR Levee Log, 2005. USACE San Joaquin O&M Manual 5, August 1961, (HLM 0.18)]. FS Date: 1/16/2014 12:03:14 PM

Slide gate in 80-inch CMP riser on WS slope.

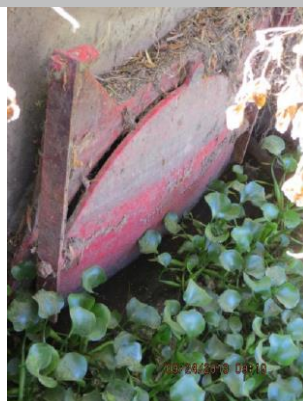
Photo 3 of 3 : UCIP_FA_2018_27123_50240.jpg

Flapgate and headwall on WS toe.

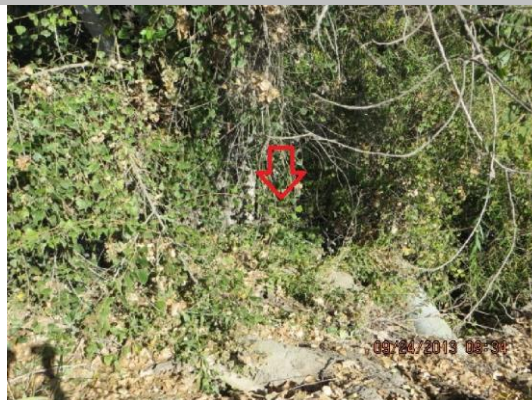
Photo 2 of 2 : UCIP_FA_2018_20885_35204.jpg

Pipe visible at rivers edge on WS toe.

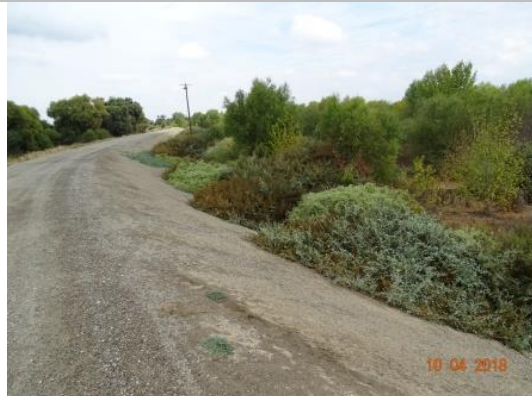
Photo 1 of 1 : FA_2018_RD2092_116_36_20181005_00048.jpg

Vegetation along landside slope and toe obstructing view. (Fall 2018)

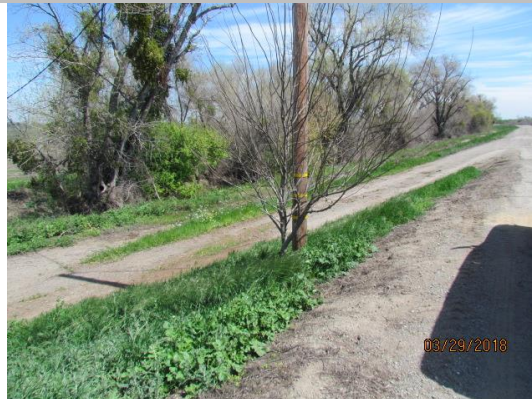
Photo 1 of 1 : FA_2018_RD2092_116_31_20180905_00012.jpg

LM Start	0.42	Rating **	M	Issue No.	28
LM End	0.42	Issue Type +	En	Location *	LS
Category	Earthen Levee			GPS Latitude/Longitude	
				Start	End
Item	Encroachments			37.601207°	37.601207°
				-121.165508°	-121.165508°
DWR ID	DWR_RD2092_01_f_2014_28				
Comment Code					
PO : Pole					
Inspector Comment

Looking upstream at small tree on waterward should next to pole. (Spring 2018)

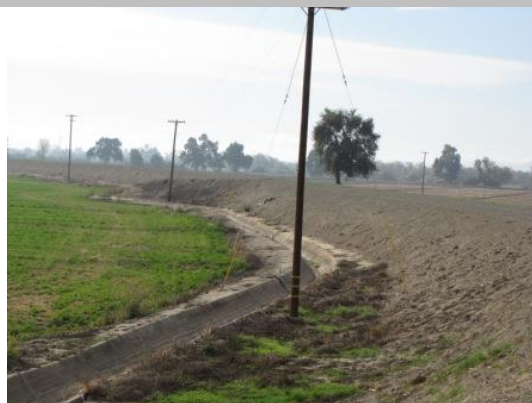
Photo 1 of 1 : FA_2018_RD2092_116_968_20180905_00018.jpg

View of agricultural ditch at the landward toe looking upstream.

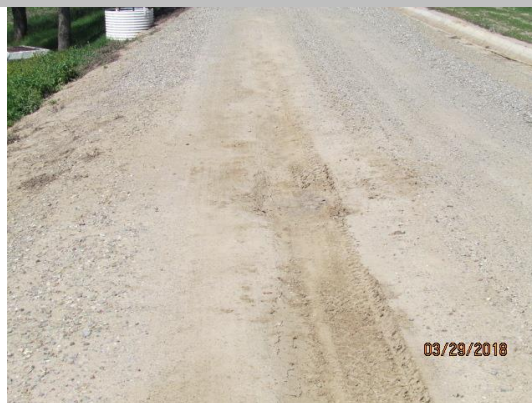
Photo 1 of 1 : FA_2018_RD2092_116_39_20180905_00017.jpg

LM Start	0.79	Rating **	M	Issue No.	42
LM End	0.83	Issue Type +	Ma	Location *	CR
Category	Earthen Levee			GPS Latitude/Longitude	
				Start	End
Item	Crown Surface / Depressions / Rutting			37.596895 °	37.596351 °
				-121.168493 °	-121.168360 °
DWR ID	DWR_RD2092_01_f_2018_42				
Comment Code					
C2 : Repair depressions or ruts in the crown or slope.					
Inspector Comment

Looking upstream at rutting and depression on levee crown. (Spring 2018)

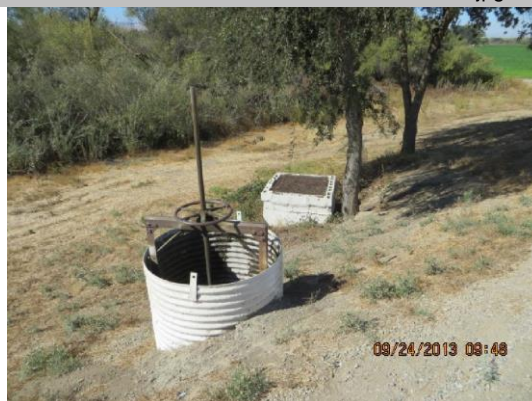
Photo 1 of 2 : UCIP_FA_2018_20889_35213.jpg

LM Start	1.30	Rating **	A/W	Issue No.	976	
LM End	1.30	Issue Type +	Ma	Location *		
Category	Supplemental			GPS Latitude/Longitude		
				Start	End	
Item	DWR UCIP LMA Responsibility			37.590603 °	37.590603 °	
				-121.164111 °	-121.164111 °	
DWR ID	20562					
Comment Code						
Inspector Comment						
FS_ID:20889						
DS_ID:20562						
EP_NO: N/A						
Repair Type: No Action Needed						
Crossing Status: Found						
UCIP Comments:						
FIELD_STRUCT_DESC: 36-inch corrugated metal drainage pipe through the levee, 15 feet below the crown. Slide gate in a 48-inch corrugated metal pipe (CMP) riser on the waterside (WS) slope. 4-foot by 6-foot concrete distribution box on the landside (LS) toe. 5-foot by 5-foot concrete riser on the WS toe. [Additional Reference(s): DWR Levee Log, 2005. USACE San Joaquin O&M Manual 5, August 1961, (HLM 1.31)].						
FS Date: 9/24/2013

Slide gate in 48-inch CMP riser on WS slope.

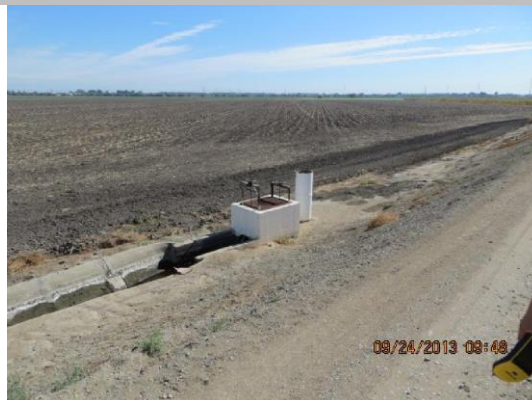
Photo 2 of 2 : UCIP_FA_2018_20889_35212.jpg

Concrete distribution box at concrete canal on LS toe.

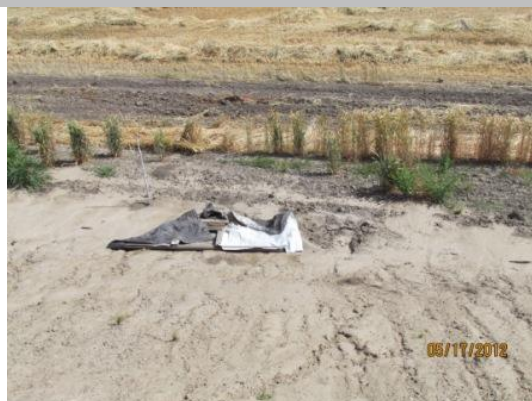
Photo 1 of 2 : FA_2018_RD2092_116_10_20180905_00002.jpg

LM Start	1.32	Rating **	A/W	Issue No.	10
LM End	1.32	Issue Type +	Ma	Location *	LS
Category	Earthen Levee			GPS Latitude/Longitude	
				Start	End
Item	Encroachments			37.590467 °	37.590467 °
				-121.163822 °	-121.163822 °
DWR ID	DWR_RD2092_01_s_2012_10				
Comment Code					
PI : Pipe					
Inspector Comment					
A sand boil appeared on the landside toe of the levee because of an underground pipe leakage. The pipe and boil have been repaired but should be monitored.

During spring inspection 2012, the sand boil was not active but materials were present on the landside toe of the levee. The sand boil occurred due to an underground irrigation pipe leakage. The picture was taken from the crown looking toward the toe of the levee. The area was repaired but should be monitored.

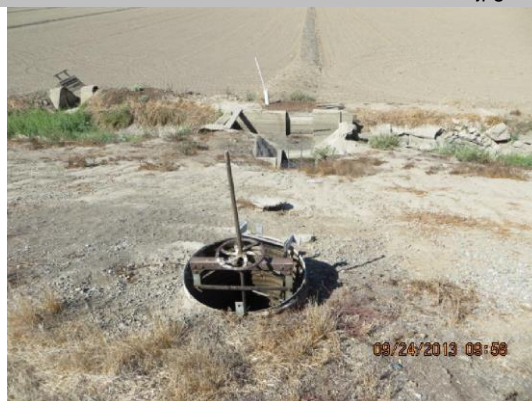
Photo 1 of 3 : UCIP_FA_2018_20891_35216.jpg

LM Start	1.69	Rating **	A/W	Issue No.	977
LM End	1.69	Issue Type +	Ma	Location *	
Category	Supplemental			GPS Latitude/Longitude	
				Start	End
Item	DWR UCIP LMA Responsibility			37.585938 °	37.585938 °
				-121.163348 °	-121.163348 °
DWR ID	20563				
Comment Code					
Inspector Comment					
FS_ID:20891 DS_ID:20563 EP_NO: N/A Repair Type: No Action Needed Crossing Status: Found UCIP Comments: FIELD_STRUCT_DESC: 24-inch corrugated metal drainage pipe through the levee, 14 feet below the crown. Slide gate in a corrugated metal pipe (CMP) riser on the waterside (WS) slope. Concrete U-shaped headwall at the landside (LS) toe. [Additional Reference(s): DWR Levee Log, 2005. USACE San Joaquin O&M Manual 5, August 1961, (HLM 1.71)]. FS Date: 9/24/2013

Slide gate in 36-inch CMP riser on WS slope.

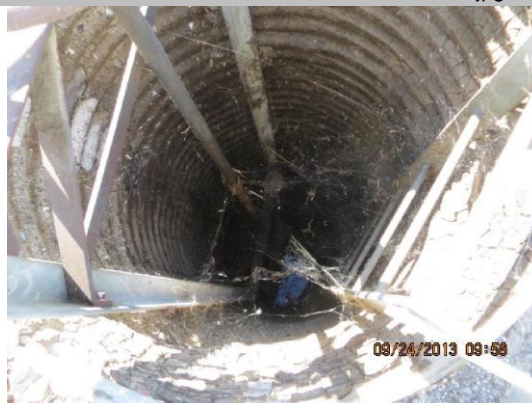
Photo 2 of 3 : UCIP_FA_2018_20891_35215.jpg

Slide gate in 36-inch CMP riser on WS slope.

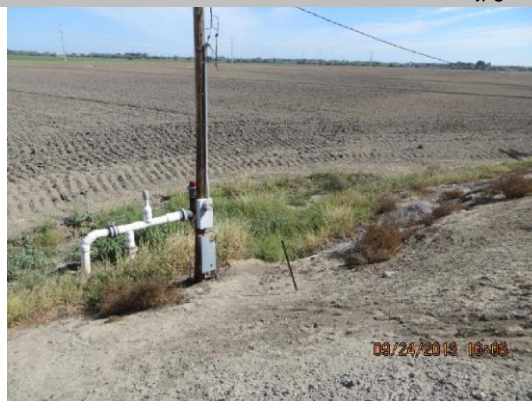
Photo 1 of 2 : UCIP_FA_2018_20904_35221.jpg

LM Start	2.07	Rating **	A/W	Issue No.	978
LM End	2.07	Issue Type +	Ma	Location *	
Category	Supplemental			GPS Latitude/Longitude	
				Start	End
Item	DWR UCIP LMA Responsibility			37.584212 °	37.584212 °
				-121.158347 °	-121.158347 °
DWR ID	20564				
Comment Code					
Inspector Comment					
FS_ID:20904 DS_ID:20564 EP_NO: N/A Repair Type: No Action Needed Crossing Status: Found UCIP Comments: FIELD_STRUCT_DESC: *ABANDONED* 30-inch corrugated metal drainage pipe through the levee, 15 feet below the crown. Flap gate on the waterside (WS) end. Concrete U-shaped headwalls on both ends. Filled with concrete on the landside (LS) toe. [Additional Reference(s): DWR Levee Log, 2005. USACE San Joaquin O&M Manual 5, August 1961, (HLM 2.10), 36-inch pipe listed]. FS Date: 9/24/2013

Pipe and concrete headwall visible on LS toe to right of powerpole.

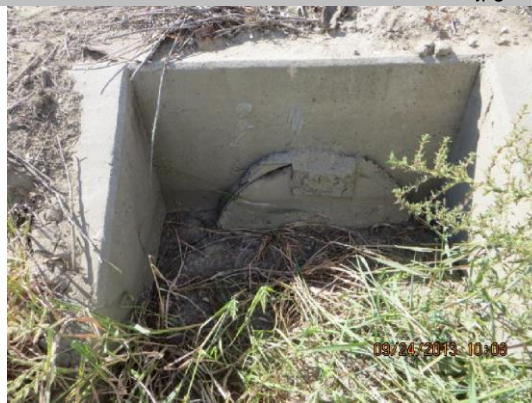
Photo 2 of 2 : UCIP_FA_2018_20904_35220.jpg

Pipe and concrete headwall visible on LS toe.

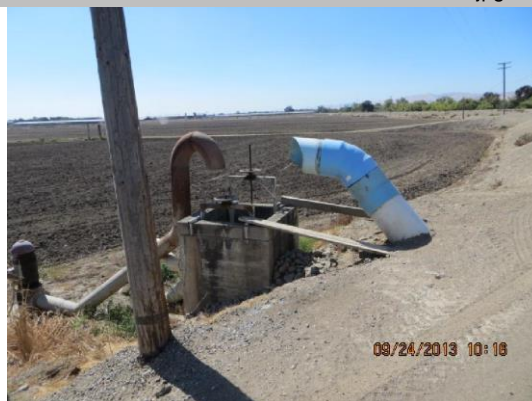
Photo 1 of 3 : UCIP_FA_2018_22916_39046.jpg

FS_ID:22916
DS_ID:24680
EP_NO: N/A
Repair Type: Non-Urgent
Crossing Status: Found
UCIP Comments: 09/24/2013 No permit identified for this crossing. (W. Wylie - DWR UCIP)
FIELD_STRUCT_DESC: 21-inch polyvinyl chloride (PVC) irrigation pipe through the levee, at an unknown depth. Pipe discharges into a concrete distribution box on the landside (LS) toe. Pump on pier off the waterside (WS) toe. [Additional Reference(s): DWR Levee Log, 2005].
FS Date: 9/24/2013

21-inch PVC irrigation pipe visible on LS shoulder.

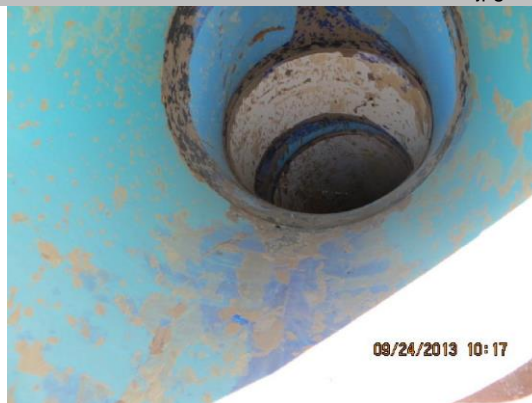
Photo 2 of 3 : UCIP_FA_2018_22916_39045.jpg

Inside of pipe at LS shoulder.

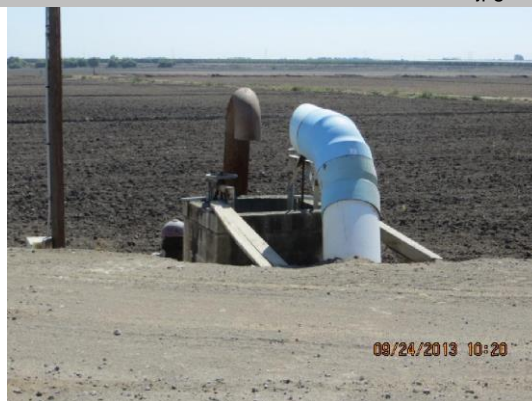
Photo 3 of 3 : UCIP_FA_2018_22916_39044.jpg

21-inch PVC irrigation pipe visible on LS shoulder.

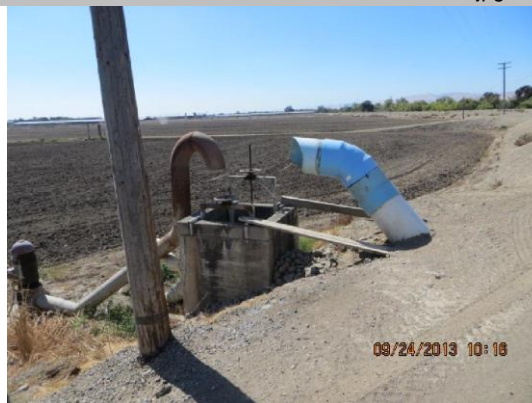
Photo 1 of 3 : UCIP_FA_2018_20908_35229.jpg

Comment Code					
Inspector Comment					
FS_ID:20908 DS_ID:20566 EP_NO: N/A Repair Type: Non-Urgent Crossing Status: Found UCIP Comments: 09/24/2013 Pipe appears abandoned and needs to be verified as having been done so properly. (W. Wylie - DWR UCIP) FIELD_STRUCT_DESC: *ABANDONED* 24-inch corrugated metal irrigation pipe through the levee, 11 feet below the crown. Slide gate in a 36-inch corrugated metal pipe (CMP) riser on the waterside (WS) slope. 5-foot by 5-foot concrete distribution box on the landside (LS). Pump on platform in the channel. Pipe filled with concrete on the LS toe. [Additional Reference(s): DWR Levee Log, 2005. USACE San Joaquin O&M Manual 5, August 1961, (HLM 2.38)]. FS Date: 9/24/2013

5x5 concrete distributuion box on LS toe.

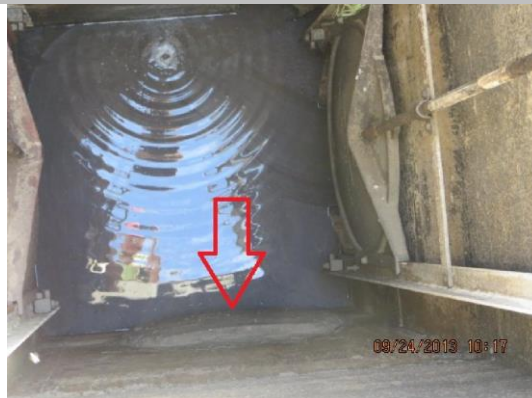
Photo 2 of 3 : UCIP_FA_2018_20908_35227.jpg

Pipe filled with concrete inside conc. distro box on LS toe.

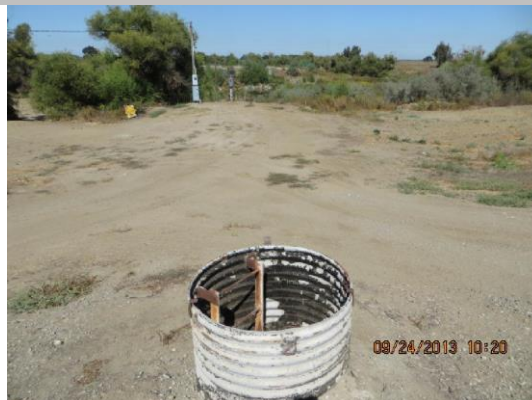
Photo 3 of 3 : UCIP_FA_2018_20908_35223.jpg

36-inch CMP riser on WS slope.

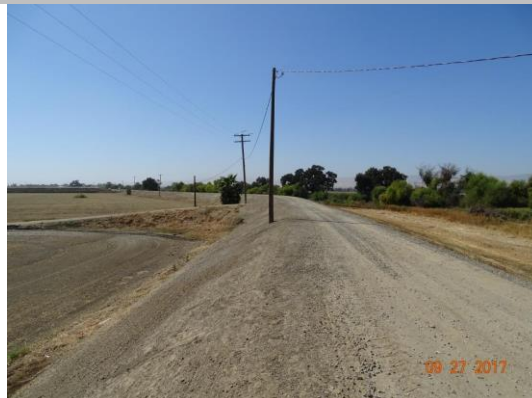
Photo 1 of 1 : FA_2018_RD2092_116_20_20180905_00009.jpg

View of the pole on the landside slope of the levee looking upstream.

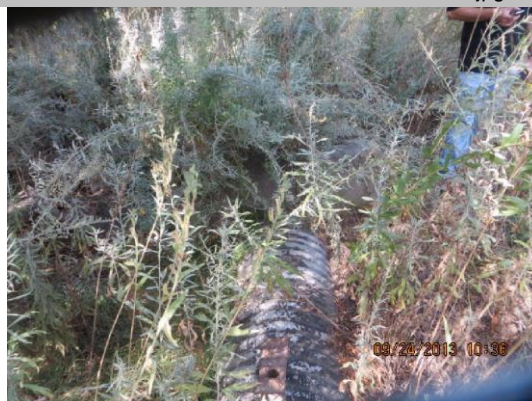
Photo 1 of 3 : UCIP_FA_2018_20943_35251.jpg

LM Start	2.40	Rating **	M	Issue No.	981	
LM End	2.40	Issue Type +	Ma	Location *		
Category	Supplemental			GPS Latitude/Longitude		
				Start		End
Item	DWR UCIP LMA Responsibility			37.580426 °	37.580426 °	
				-121.156798 °	-121.156798 °	
DWR ID	20567					
Comment Code						
Inspector Comment						
FS_ID:20943 DS_ID:20567 EP_NO: N/A Repair Type: Non-Urgent Crossing Status: Found UCIP Comments: 09/24/2013 Appears abandoned and if so should be done so properly. (W. Wylie - DWR UCIP) FIELD_STRUCT_DESC: *ABANDONED* 24-inch corrugated metal drainage pipe through the levee, 15 feet below the crown. Flap gate on the waterside (WS) end. Concrete U-shaped headwall on the WS end. Concrete headwall on the landside (LS) toe next to pump. [Additional Reference(s): DWR Levee Log, 2005. USACE San Joaquin O&M Manual 5, August 1961, (HLM 2.44)]. FS Date: 9/24/2013

24-inch pipe visible on WS berm.

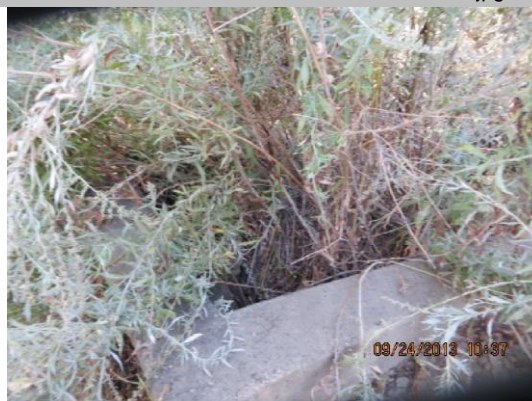
Photo 2 of 3 : UCIP_FA_2018_20943_35250.jpg

Concrete U-shaped headwall and flapgate on WS berm.

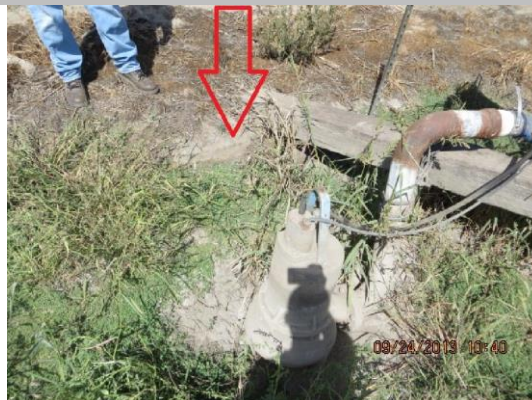
Photo 3 of 3 : UCIP_FA_2018_20943_35252.jpg

Concrete headwall next to pump on WS toe.

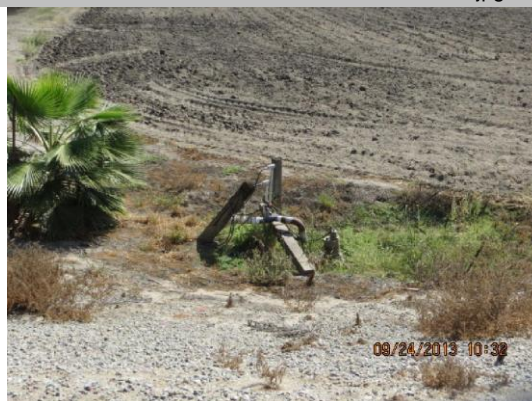
Photo 1 of 3 : UCIP_FA_2018_20923_35234.jpg

LM Start	2.41	Rating **	M	Issue No.	982	
LM End	2.41	Issue Type +	En	Location *		
Category	Supplemental			GPS Latitude/Longitude		
				Start	End	
Item	DWR UCIP Field Study			37.580405 °	37.580405 °	
				-121.156825 °	-121.156825 °	
DWR ID	20568					
Comment Code						
Inspector Comment						
FS_ID:20923						
DS_ID:20568						
EP_NO: N/A						
Repair Type: Non-Urgent						
Crossing Status: Indicator Found						
UCIP Comments: 09/24/2013 Pipe abandoned and should be verified as having been removed from the levee. (W. Wylie - DWR UCIP)						
FIELD_STRUCT_DESC: *ABANDONED* 4-inch drainage pipe of an unknown material through the levee, 1 foot below the crown. Pump on sump at the landside (LS) toe. Roadway extending to the LS pump.						
[Additional Reference(s): DWR Levee Log, 2005].						
FS Date: 9/24/2013

Pump and 4-inch pipe visible at LS toe.

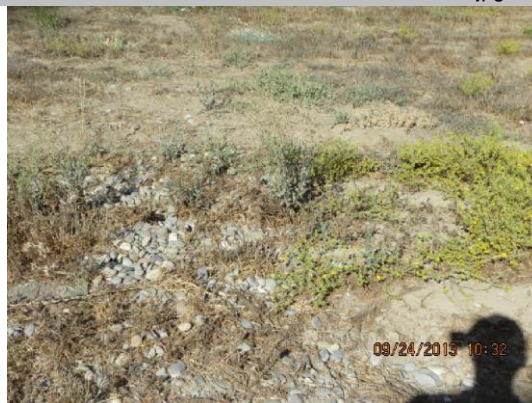
Photo 2 of 3 : UCIP_FA_2018_20923_35233.jpg

Gravel on WS slope appears to indicate trench.

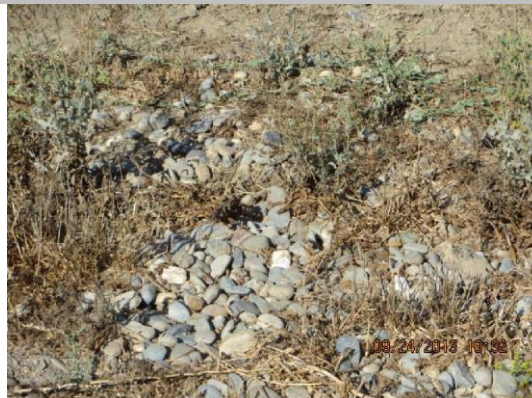
Photo 3 of 3 : UCIP_FA_2018_20923_35232.jpg

Gravel on WS slope appears to indicate trench.

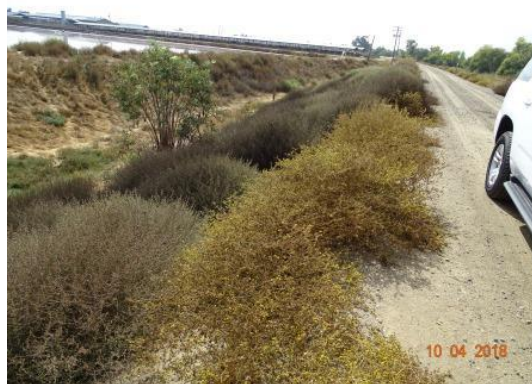
Photo 1 of 1 : FA_2018_RD2092_116_25_20181005_00054.jpg

LM Start	2.42	Rating **	U	Issue No.	25
LM End	2.71	Issue Type +	Ma	Location *	LS
Category	Earthen Levee			GPS Latitude/Longitude	
				Start	End
Item	Vegetation			37.580202°	37.576059°
				-121.156904°	-121.157241°
DWR ID	DWR_RD2092_01_f_2018_25				
Comment Code					
V1 : Control annual grass and weeds on the levee slopes and easements.					
Inspector Comment					
View of landside slope completely obstructed up vegetation.

View of vegetation along landside slope looking upstream. (Fall 2018)

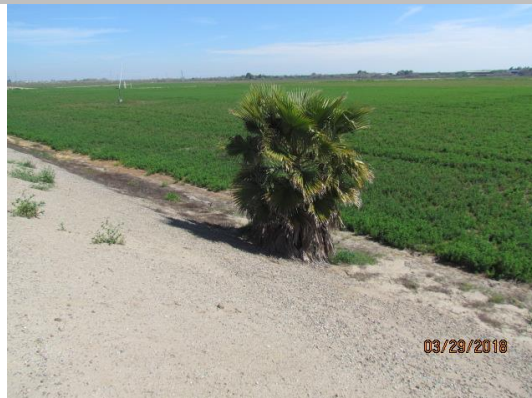
Photo 1 of 1 : FA_2018_RD2092_116_19_20180905_00008.jpg

Looking at Palm tree at landward toe. (Spring 2018)

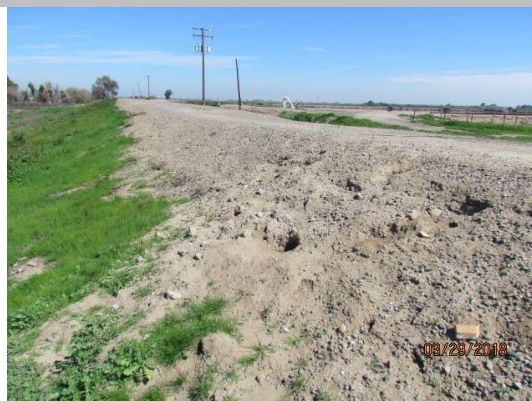
Photo 1 of 4 : FA_2018_RD2092_116_17_20180905_00004.jpg

Looking upstream on waterward slope at several large rodent holes.
(Spring 2018)

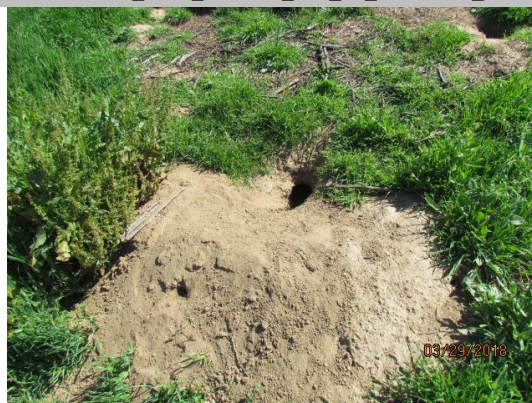
Photo 2 of 4 : FA_2018_RD2092_116_17_20180905_00005.jpg

Looking at typical large rodent holes on waterward slope. (Spring 2018)

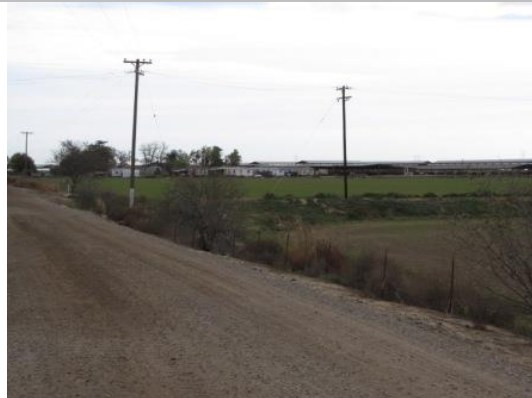
Photo 1 of 1 : FA_2018_RD2092_116_972_20180905_00019.jpg

View of barbed wire fence along the waterward slope looking upstream.

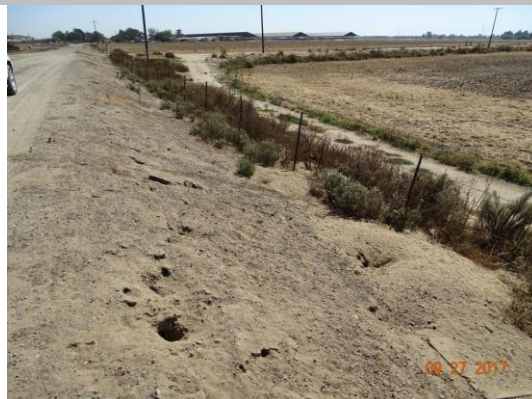
Photo 1 of 4 : FA_2018_RD2092_116_35_20180905_00013.jpg

Updated picture of the rodent holes on the waterside of the levee looking upstream. Fall 2017

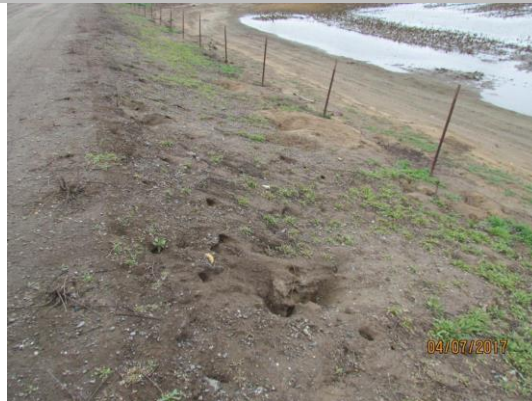
Photo 2 of 4 : FA_2018_RD2092_116_35_20180905_00014.jpg

View of multiple rodent holes on the waterside slope of the levee. Spring 2017

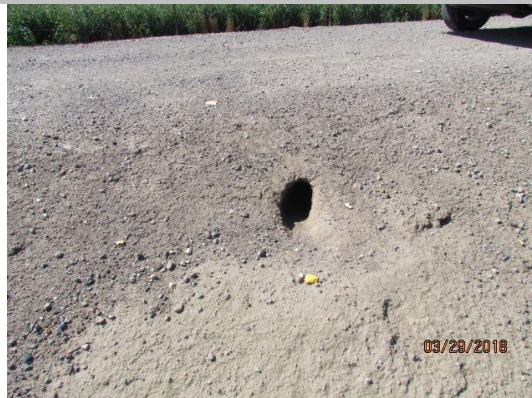
Photo 3 of 4 : FA_2018_RD2092_116_35_20180905_00015.jpg

Looking at Typical view of rodent holes on landward sloop within this reach. (Spring 2018)

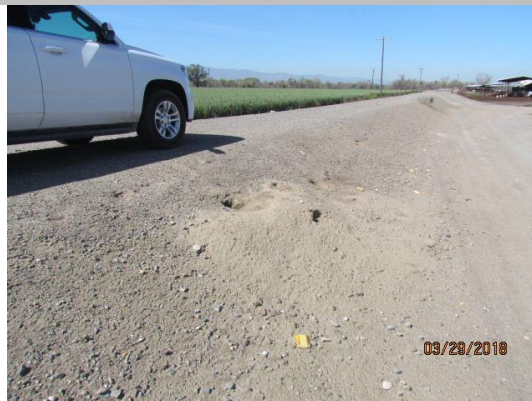
Photo 4 of 4 : FA_2018_RD2092_116_35_20180905_00016.jpg

Looking upstream at several rodent holes on landward slope. (Spring 2018)

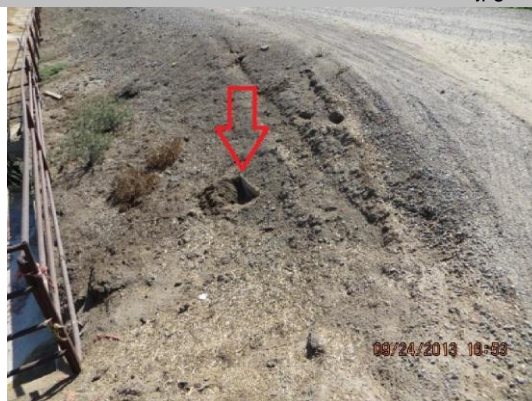
Photo 1 of 1 : UCIP_FA_2018_20944_35255.jpg

LM Start	2.86	Rating **	M	Issue No.	983
LM End	2.86	Issue Type +	En	Location *	
Category	Supplemental			GPS Latitude/Longitude	
				Start	End
Item	DWR UCIP Field Study			37.574741 °	37.574741 °
				-121.155495 °	-121.155495 °
DWR ID	20570				
Comment Code					
Inspector Comment					
FS_ID:20944 DS_ID:20570 EP_NO: N/A Repair Type: Non-Urgent Crossing Status: Indicator Found UCIP Comments: 09/24/2013 Appears abandoned and if so, should be done so properly. (W. Wylie - DWR UCIP) FIELD_STRUCT_DESC: *ABANDONED* 24-inch corrugated metal drainage pipe through the levee, 6.5 feet below the crown. Concrete U-shaped headwall and flap gate on the waterside (WS) end. Concrete headwall on the landside (LS) slope. [Additional Reference(s): DWR Levee Log, 2005. USACE San Joaquin O&M Manual 5, August 1961]. FS Date: 9/24/2013

Concrete headwall visible on LS slope.

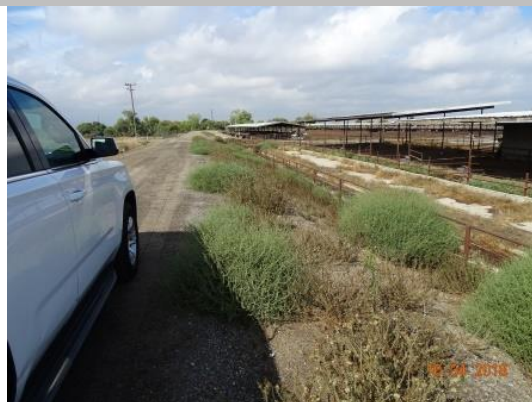
Photo 1 of 1 : FA_2018_RD2092_116_16_20181005_00057.jpg

Vegetation along landside slope. (Fall 2018)

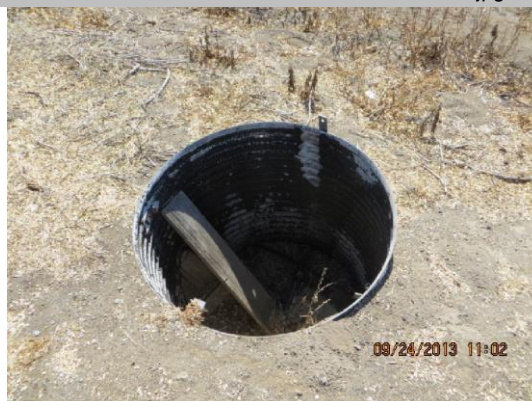
Photo 1 of 3 : UCIP_FA_2018_20945_35261.jpg

LM Start	3.47	Rating **	M	Issue No.	984
LM End	3.47	Issue Type +	Ma	Location *	
Category	Supplemental			GPS Latitude/Longitude	
				Start	End
Item	DWR UCIP LMA Responsibility			37.573304 °	37.573304 °
				-121.144747 °	-121.144747 °
DWR ID	20572				
Comment Code					
Inspector Comment					
FS_ID:20945					
DS_ID:20572					
EP_NO: N/A					
Repair Type: Non-Urgent					
Crossing Status: Found					
UCIP Comments: 09/24/2013 This pipe appears abandoned and if so, should be done so properly. (W. Wylie - DWR UCIP)					
FIELD_STRUCT_DESC: *ABANDONED* 36-inch corrugated metal drainage pipe through the levee, 11 feet below the crown. Slide gate in a corrugated metal pipe (CMP) riser on the waterside (WS) slope. Concrete headwalls on both ends. [Additional Reference(s): DWR Levee Log, 2005. USACE San Joaquin O&M Manual 5, August 1961, (HLM 3.52)].					
FS Date: 9/24/2013

48-inch CMP riser on WS slope.

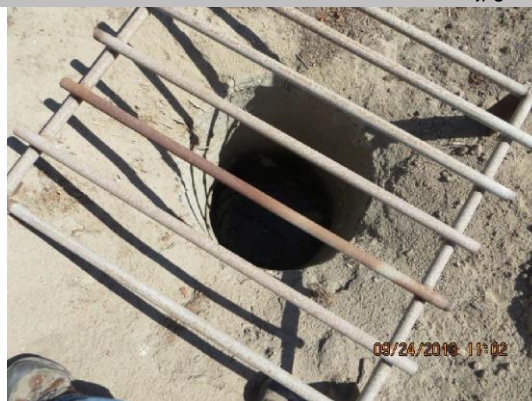
Photo 3 of 3 : UCIP_FA_2018_20945_35262.jpg

Grate over sump on LS toe.
